MARINE INVESTIGATION REPORT
M02W0102

CAPSIZING

SMALL FISHING VESSEL *FRITZI-ANN*
NEAR KELSEY BAY, BRITISH COLUMBIA
08 JULY 2002

Report Number M02W0102

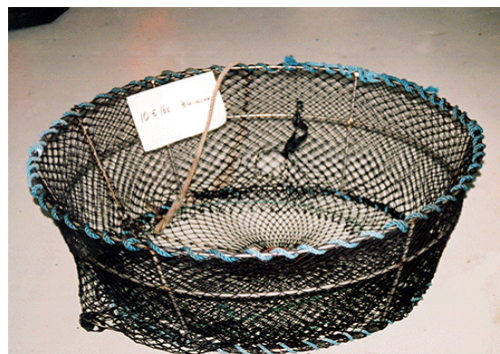
Photo 2. Modern prawn trap (170 litres)

Concerned about conservation and sustainability in the prawn industry stemming from inappropriate use of the older bucket-type prawn traps, DFO set the upper limits for traps by volume and mesh size in 1995. The specifications were set at 170 litre volume and 38.1 mm mesh size, but no consideration was given to the weight of the traps. When licence holders acted to make their traps more robust and keep their volumetric shape and size, the weight of traps increased from 2 kg to 5 kg.

In 1995, acting out of concerns for conservation of prawn and shrimp stocks, DFO specified the required dimensions of traps based on volumetric and mesh size considerations. Since the maximum allowable weight of a trap was not specified, licence holders decided to maximize the catch size by having the traps made more robust to keep their volumetric shape. Thus, the weight of prawn traps has progressively increased toward 5 kg. As trap weights are not a consideration in the management of fisheries, their weights are not recorded. TC was not contacted to determine whether there were safety implications.

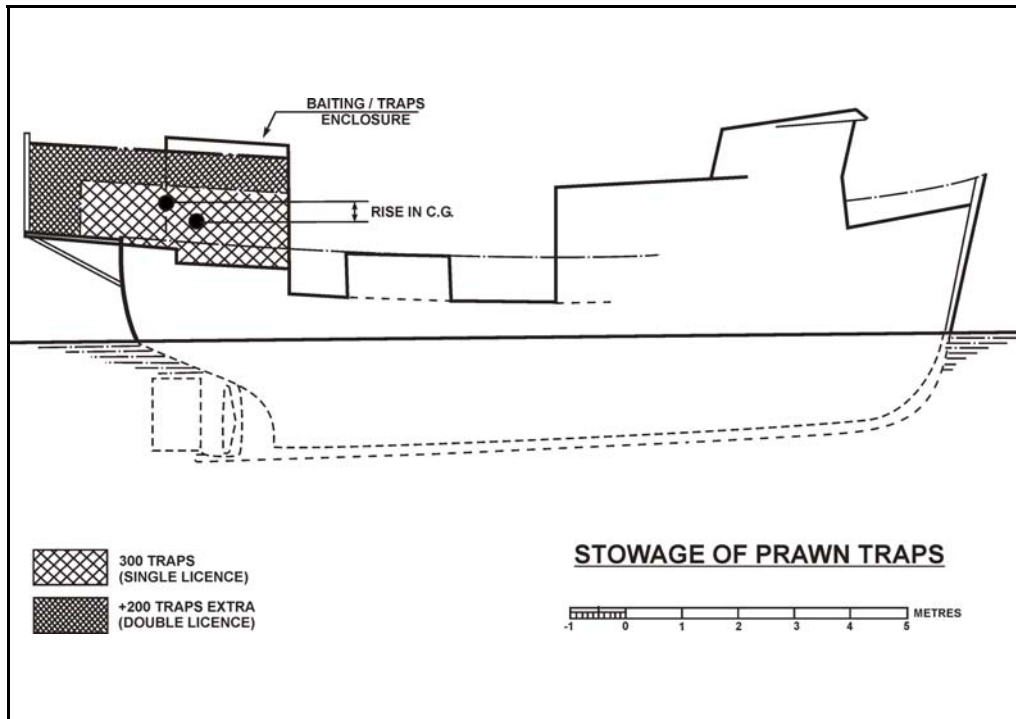
Figure 1. Stowage of prawn traps

TC accepted the 1990 figures as indicative of the vessel's stability at that time, subject to the owner/operator following the instructions provided. In this occurrence, 500 prawn traps were stowed on the after part of the weather deck. The instructions that no additional weights be added high on the vessel and gear for fishing operations be stowed as low in the vessel as possible were not followed. About 30 per cent of the total traps at the stern were situated higher than the deckhouse top, rather than low in the empty hold.

The RTL licence granted to the *Fritzi-Ann* led to practices that further adversely affected the vessel's transverse stability. The area of the deck and platform extensions available for the stowage of traps increased 20 per cent by adding the second extension, but the trap capacity increased in volume by 67 per cent. This resulted in the *Fritzi-Ann* carrying 500 traps at an average height about 40 per cent greater than the 300 carried previously as a single licensed vessel (see Figure 1).

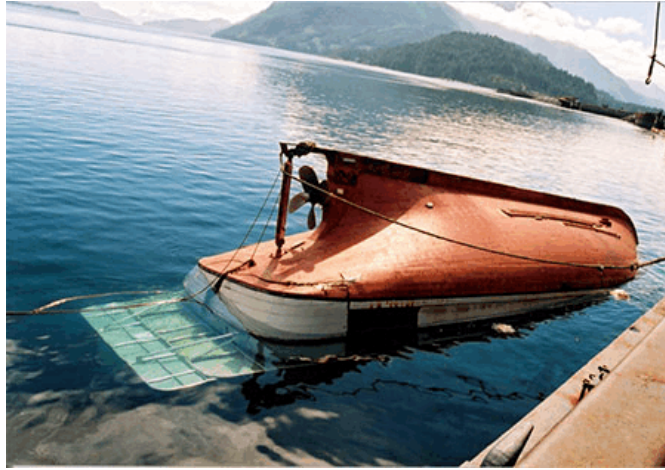
When the radiotelephone failed to work, the skipper broke the wheelhouse window, re-entered and, using VHF channel 16, informed Comox Marine Communications and Traffic Services (MCTS) of their position and their situation. The skipper retrieved log books before escaping from the wheelhouse and rejoining the other crew members. All three donned their immersion suits and abandoned the vessel into the liferaft. Minutes later, the vessel capsized completely, floating in the overturned condition. (See Appendix B for photographs of the capsized *Fritzi-Ann*.)

Photo 3. Capsized *Fritzi-Ann* alongside wharf, showing submerged deck extensions

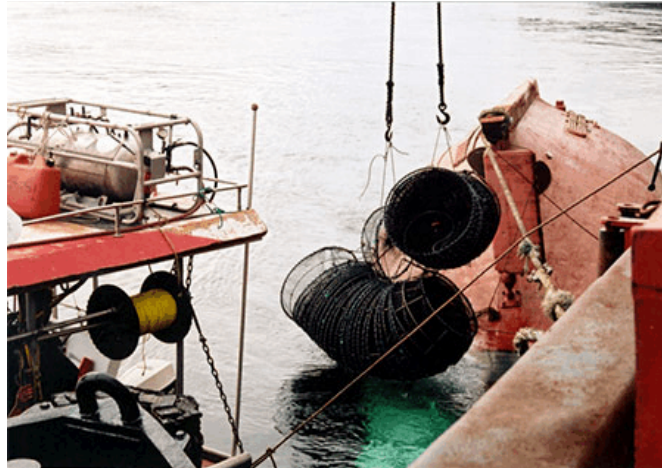
- In the light condition with 500 traps on the after deck, the average GM of 0.233 m is 33.4 per cent lower than the minimum required by STAB 4, showing a considerable reduction of the already low initial transverse stability due to the weight and location of the fishing traps.

Photo 4. Prawn traps retrieved from capsized vessel

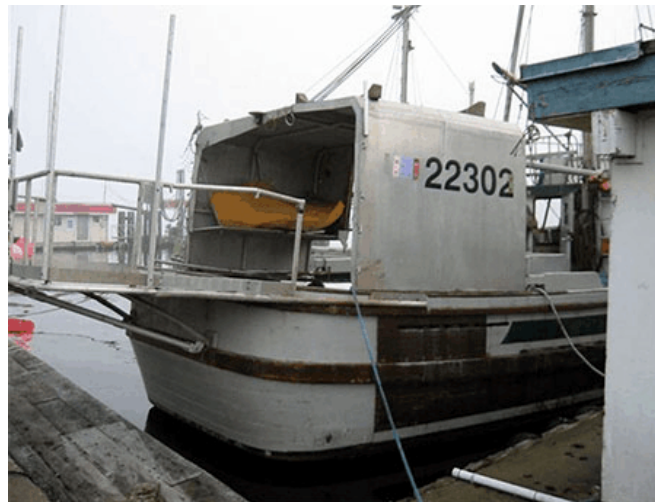
Another extension of about 0.91 m was added in about 1999 to the existing platform extension to accommodate the increase in the number of prawn traps from 300 to 500, as a result of the RTL policy provision. The overall extension is now 1.67 m. This modification was not reported to TC. The traps were stored in stacks of 25 to a height of 1.98 m above the main deck. They extended over the deck area from about 1 m aft of the fish hold hatch to the extreme after end of the extension platform. The traps averaged in weight from 2.7 kg to 5.2 kg.

The *Fritzi-Ann* qualified for an RTL licence to carry 500 traps. The licensed vessel fishes with fewer traps (500) than two single licensed ones (300 + 300). It was to stow extra fishing gear on a deck extension placed beyond the licensed length and normal limits of the hull, for which the vessel was not originally designed. This affects the behaviour and safety of a vessel at sea, but was not considered by the owner or the authorities to be a significant design change requiring safety analysis.

Photo 5. Stern view of double extension platform and baiting enclosure
